Addendum

Safety and Access to
PVTA Bus Stops

Prepared by Tatum Thomas,
UMass Master's of Regional
Planning 2023

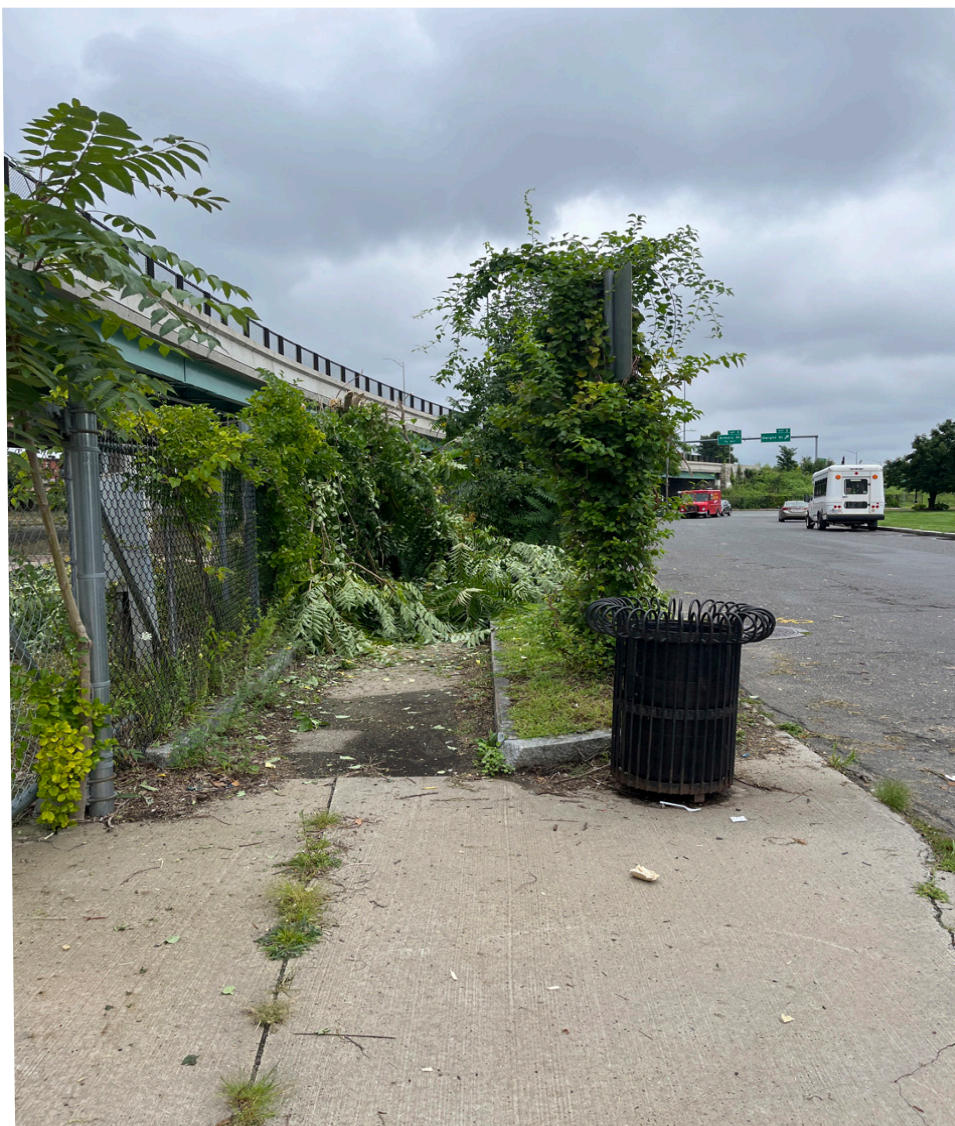
Another trend found in the study was there are reoccurring safety and accessibility barriers across all three study areas. Commonalities included discontinuities and obstructions to sidewalks, poor sidewalk width which was too narrow to be accessible, lack of lighting especially at stops, lack of crossings near stops, and inaccessible curbs.

Figure 8: Obstructed sidewalk in Springfield study area.

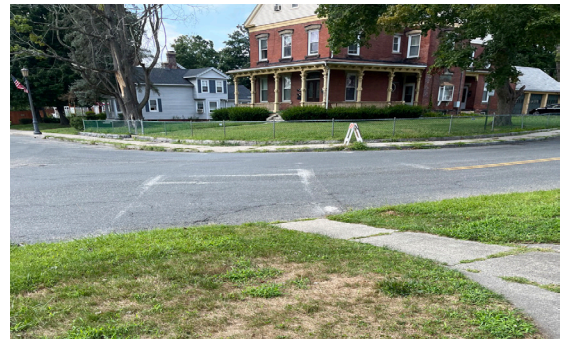
Figure 10: Poorly visible crosswalk in South Hadley study area.

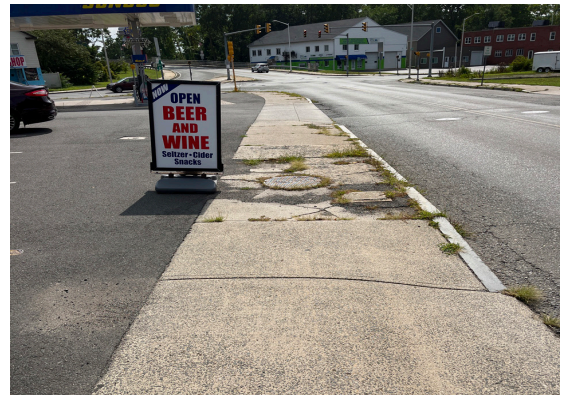
South Hadley had the most absent sidewalk infrastructure of the three study areas. It also had the lowest scores across most attributes of safety and access. All average scores were below the benchmark score of 4 except for the curb ramp score and connectivity to stop score. The lowest score for South Hadley was the stop amenities score, which was 1.78. This reflects that no stops had amenities in South Hadley, and several had no signage. Most crosswalks were poorly visible or otherwise in disrepair as can be seen in Figure 10, resulting in a score of 3.88. Sidewalk characteristics also had a low score of 2.86, reflecting the inadequate width and absence of many sidewalks in the study area. Sidewalk condition was only slightly better at an average score of 3.24. This score was due to many sidewalks containing discontinuities which may impact accessibility, as seen in Figure 11.

Figure 11: Sidewalk discontinuity in South Hadley study area.

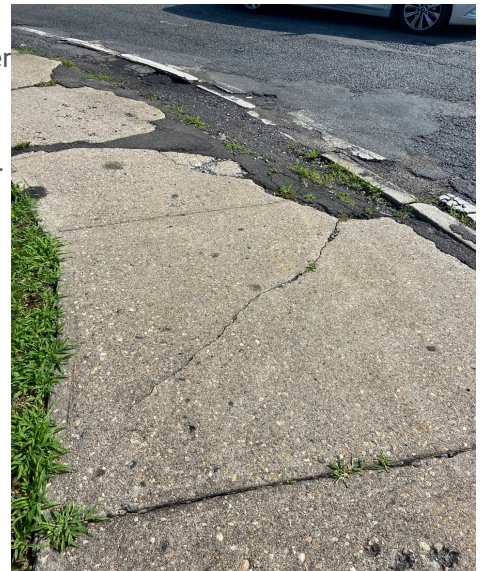
The West Springfield study area sidewalk network scored in between South Hadley and Springfield for most components. Curb ramp condition, crosswalk condition, and overall network safety were all greater than the score of 4 for sufficiency. The safety score of 4.55 represents between 3 and 4 network characteristics were sufficient on average. Despite having average scores between South Hadley and Springfield, the percentage of intersections with curb ramps and the curb ramp average score was the lowest of the three study areas in West Springfield. This represents the high percentage of crossings (38 percent) that did not have adequate curb ramps and the low score corresponds with the prevalence of curb ramps in disrepair as seen in Figure 13.

Figure 13: Image of curb ramp in West Springfield in disrepair and without accessible features.

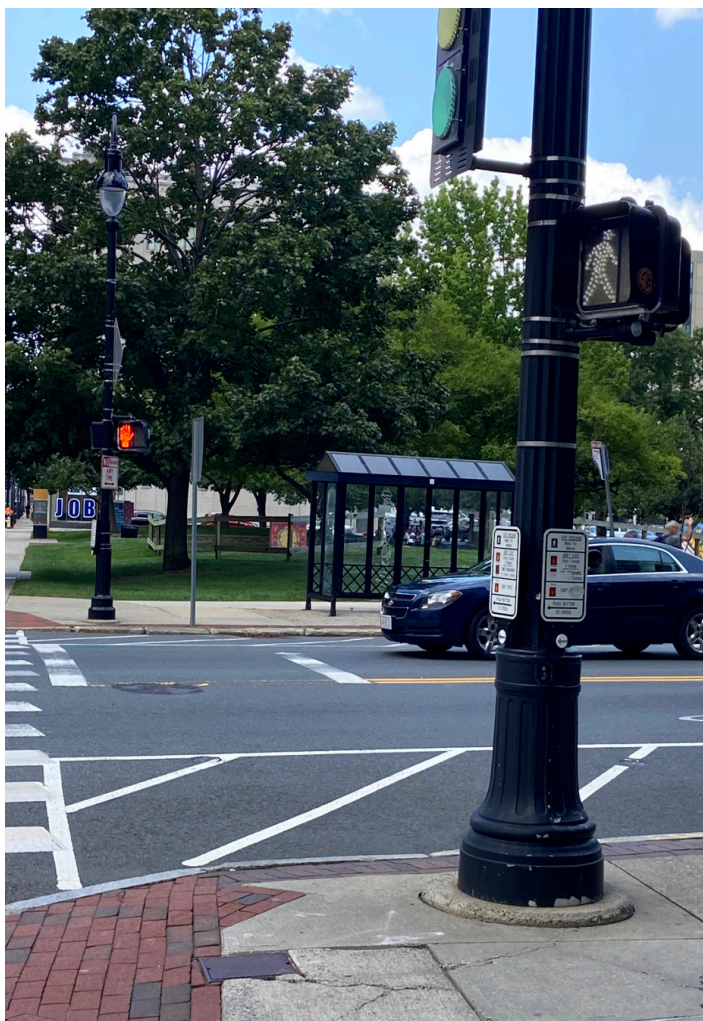
Figure 15: Crosswalk, bus shelter, and sidewalk in good condition in Springfield.

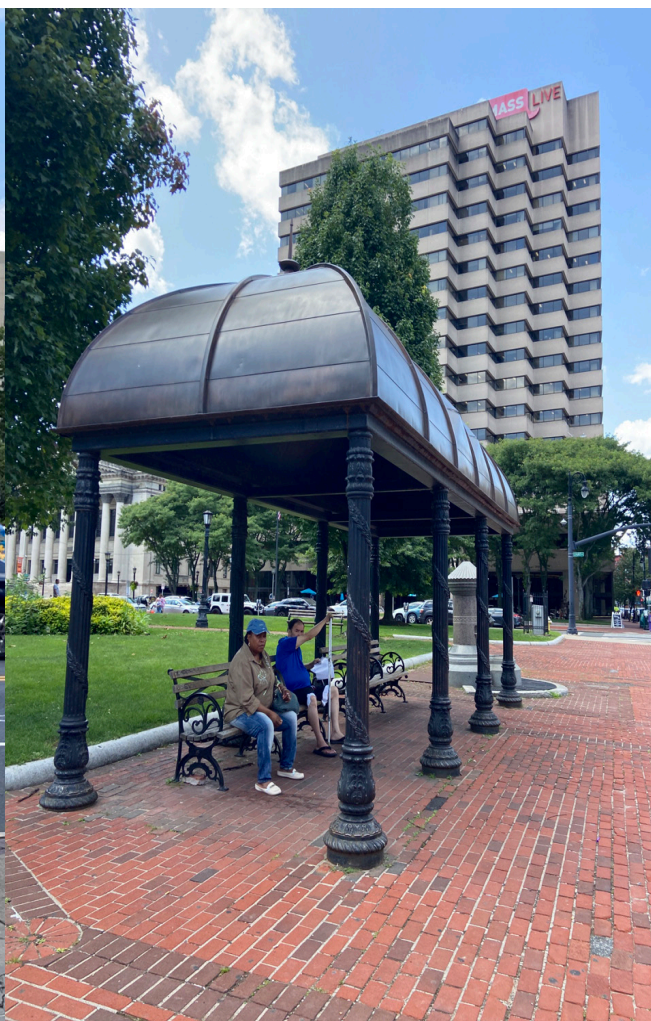
Figure 16: Bus shelter and sidewalk in good condition in Springfield.
