Addendum

Safety and Access to
PVTA Bus Stops

Prepared by Tatum Thomas,
UMass Master's of Regional
Planning 2023

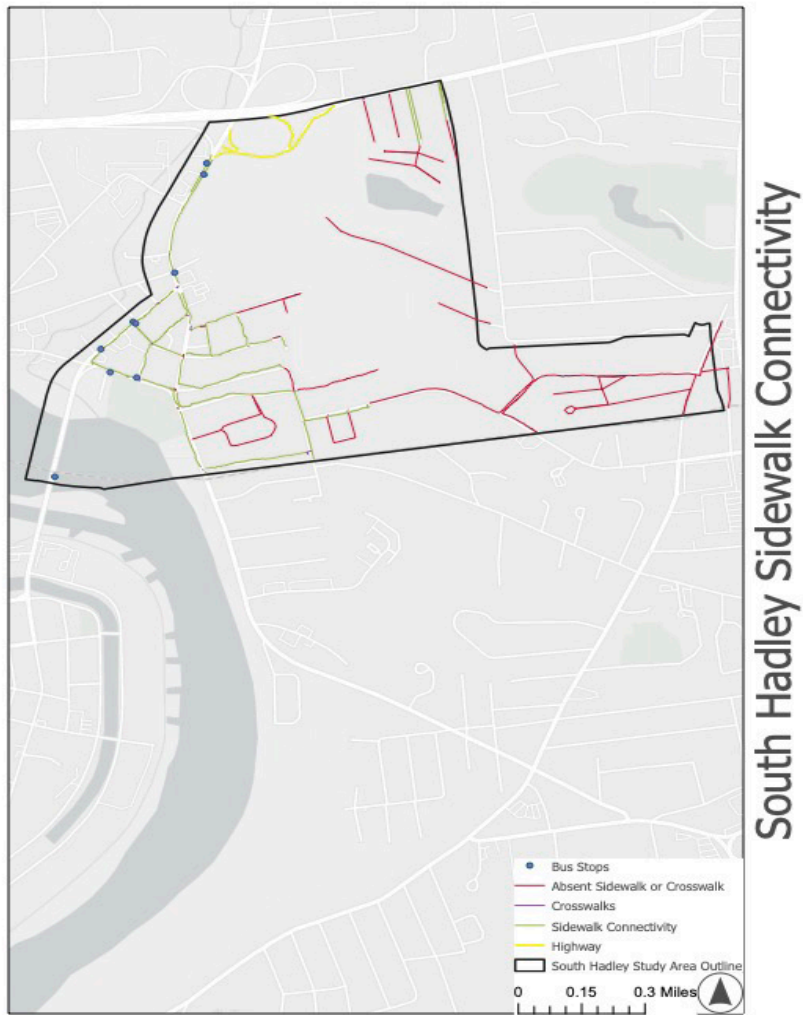
Figure 9: Field map of South Hadley study area including bus stops, sidewalks, crosswalks, and missing infrastructure.

South Hadley Network Summary	
Lighting	2.40
Sidewalk Condition	3.24
Sidewalk Characteristics	2.86
Curb Ramps	4.44
% Intersections with Curb Ramp	0.75
Crosswalk Condition	3.88
Stop Amenities	1.78
Connectivity to Stop	7.00
Safety	3.86

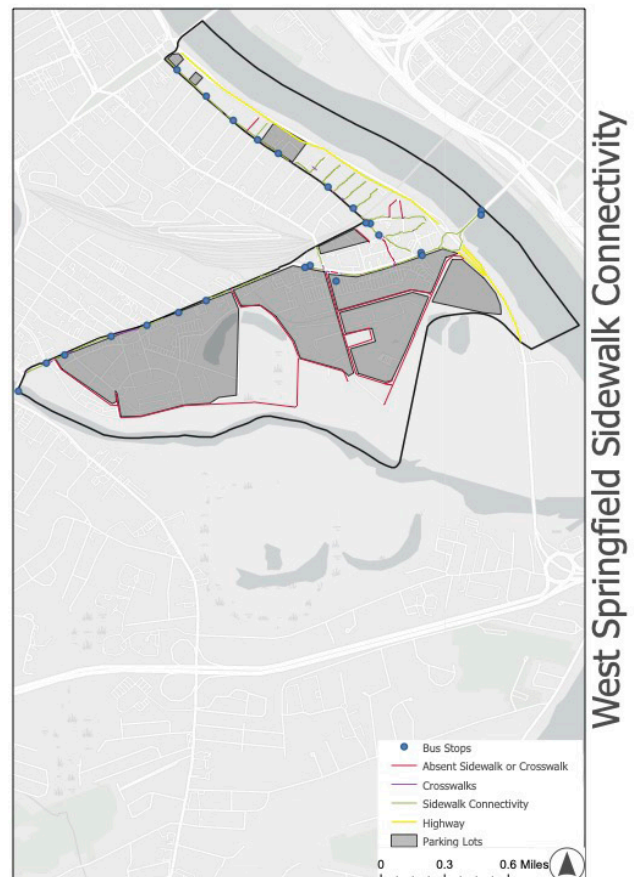
Figure 12: Field map of West Springfield study area including bus stops, sidewalks, crosswalks, and missing infrastructure.

On average, West Springfield sidewalks scored below 4 for all components, however the average scores for each component were closer to sufficient than South Hadley. The lighting score was the lowest of all average scores for the study area's sidewalk segments, at an average score of 2.73, with 13 of 49 (26.5 percent) segments scoring a 4 or higher. However, for both sidewalk condition and sidewalk characteristics, more than half (57 percent and 55 percent respectively) scored a 4 or better in the study area. The average safety score was a 3.78 for the study area, which is reflective of the high percentage of segments with sufficient scores for sidewalk condition and characteristics, as well as the low prevalence of adequate lighting which lowered the overall safety score.

The West Springfield study area sidewalk network scored in between South Hadley and Springfield for most components. Curb ramp condition, crosswalk condition, and overall network safety were all greater than the score of 4 for sufficiency. The safety score of 4.55 represents between 3 and 4 network characteristics were sufficient on average. Despite having average scores between South Hadley and Springfield, the percentage of intersections with curb ramps and the curb ramp average score was the lowest of the three study areas in West Springfield. This represents the high percentage of crossings (38 percent) that did not have adequate curb ramps and the low score corresponds with the prevalence of curb ramps in disrepair as seen in Figure 13.

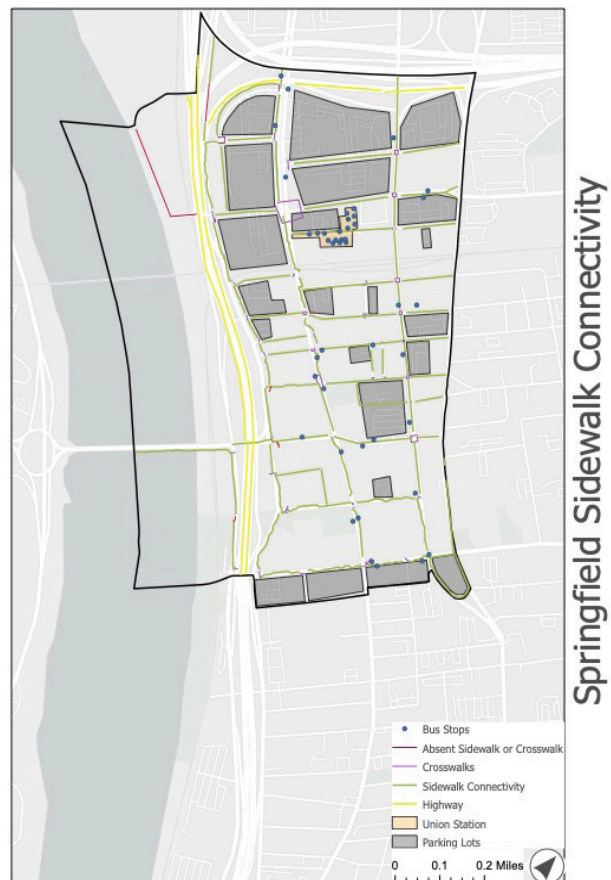
Figure 14: Field map of West Springfield study area including bus stops, sidewalks, crosswalks, and missing infrastructure.

Springfield had the highest average score of all three study areas for sidewalk components and characteristics. All the components' average scores were above the benchmark of 4 for sufficient. The average overall safety score for sidewalks in Springfield was a 5.54, which demonstrates good condition and accessibility overall. Sidewalks were present throughout all of the study area to varying degrees and this helped the average score. On average, sidewalk segments had sufficient lighting, condition, and characteristics.

Springfield also had the highest average scores for crosswalk characteristics and condition. The average curb ramp score was a 6.11, representing excellent average curb ramp condition. The percentage of intersections with curb ramps was 93 percent, indicating that nearly all crossings had curb ramps present. The crosswalk average score was a 5.30, which represents, on average, more than sufficient crosswalk condition. The average overall safety score of crosswalks in the Springfield study area was a 6.33, which represents near perfect safety on average at crossings.

Springfield's overall network averages were the highest of the three study areas, with the exception of stop amenities. All components of walking infrastructure scored above the benchmark of 4, on average, except for stop amenities, which scored a 2.75. The average stop amenity score is not entirely representative of the actual stop amenities due to the large number of bus stops, which meant that stops with amenities did not have as strong of an influence on the average score as in other study areas. Overall, the sidewalk network in Springfield was in the best condition of the three study areas.
